Debris/Ice/TPS Assessment And Photographic Analysis For Shuttle Mission STS-39

Gregory N. Katnik
NASA/Kennedy Space Center

DEBRIS/ICE/TPS ASSESSMENT
AND
PHOTOGRAPHIC ANALYSIS
OF
SHUTTLE MISSION STS-39

April 28, 1991

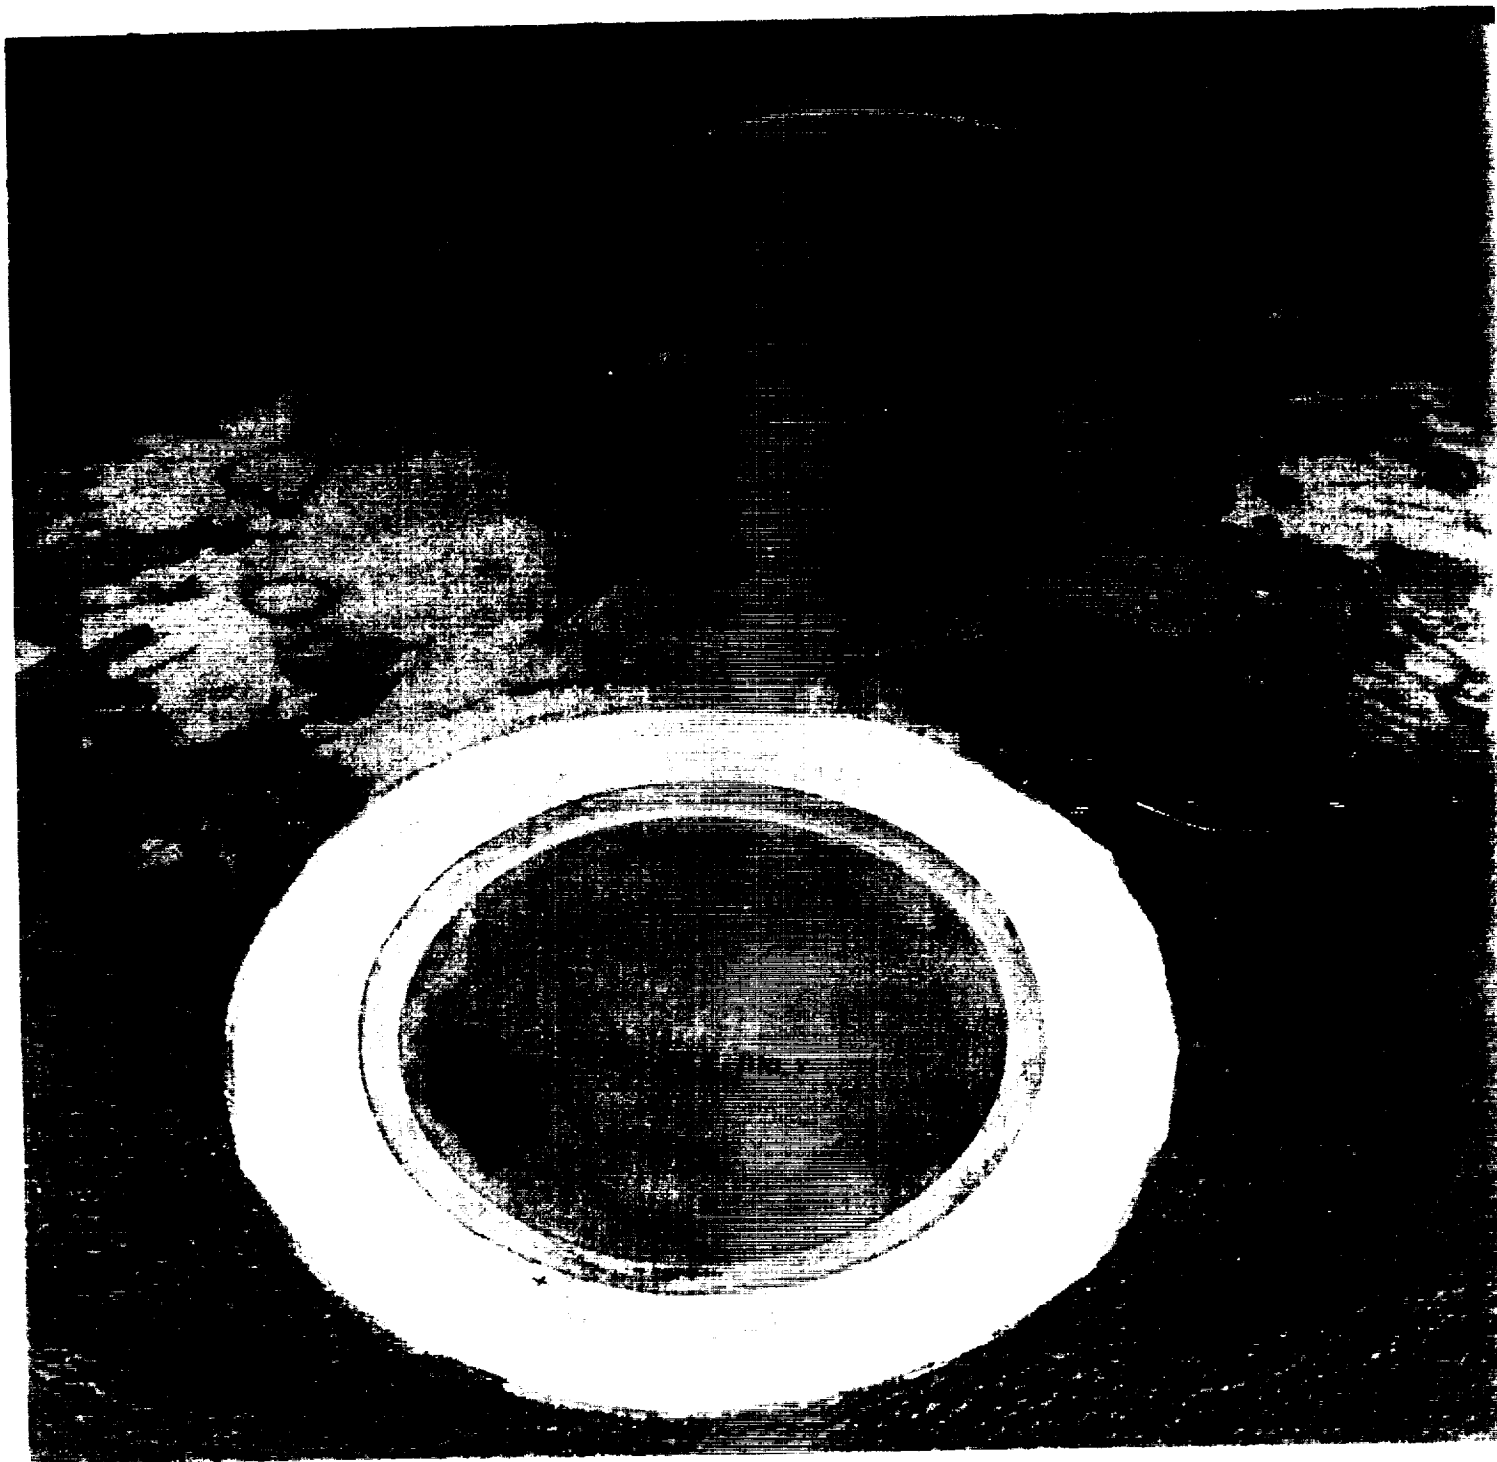
Vapors vented from the LH2 tank aft dome +Z manhole cover TPS closeout on the +Y side at the outer closeout perimeter (Anomaly 006). No TPS defect was visible.

Vapors vented from the LH2 tank aft dome +Z manhole cover TPS closeout (+Y side) at the outer closeout perimeter during cryoload and drain. No TPS anomaly was visible.

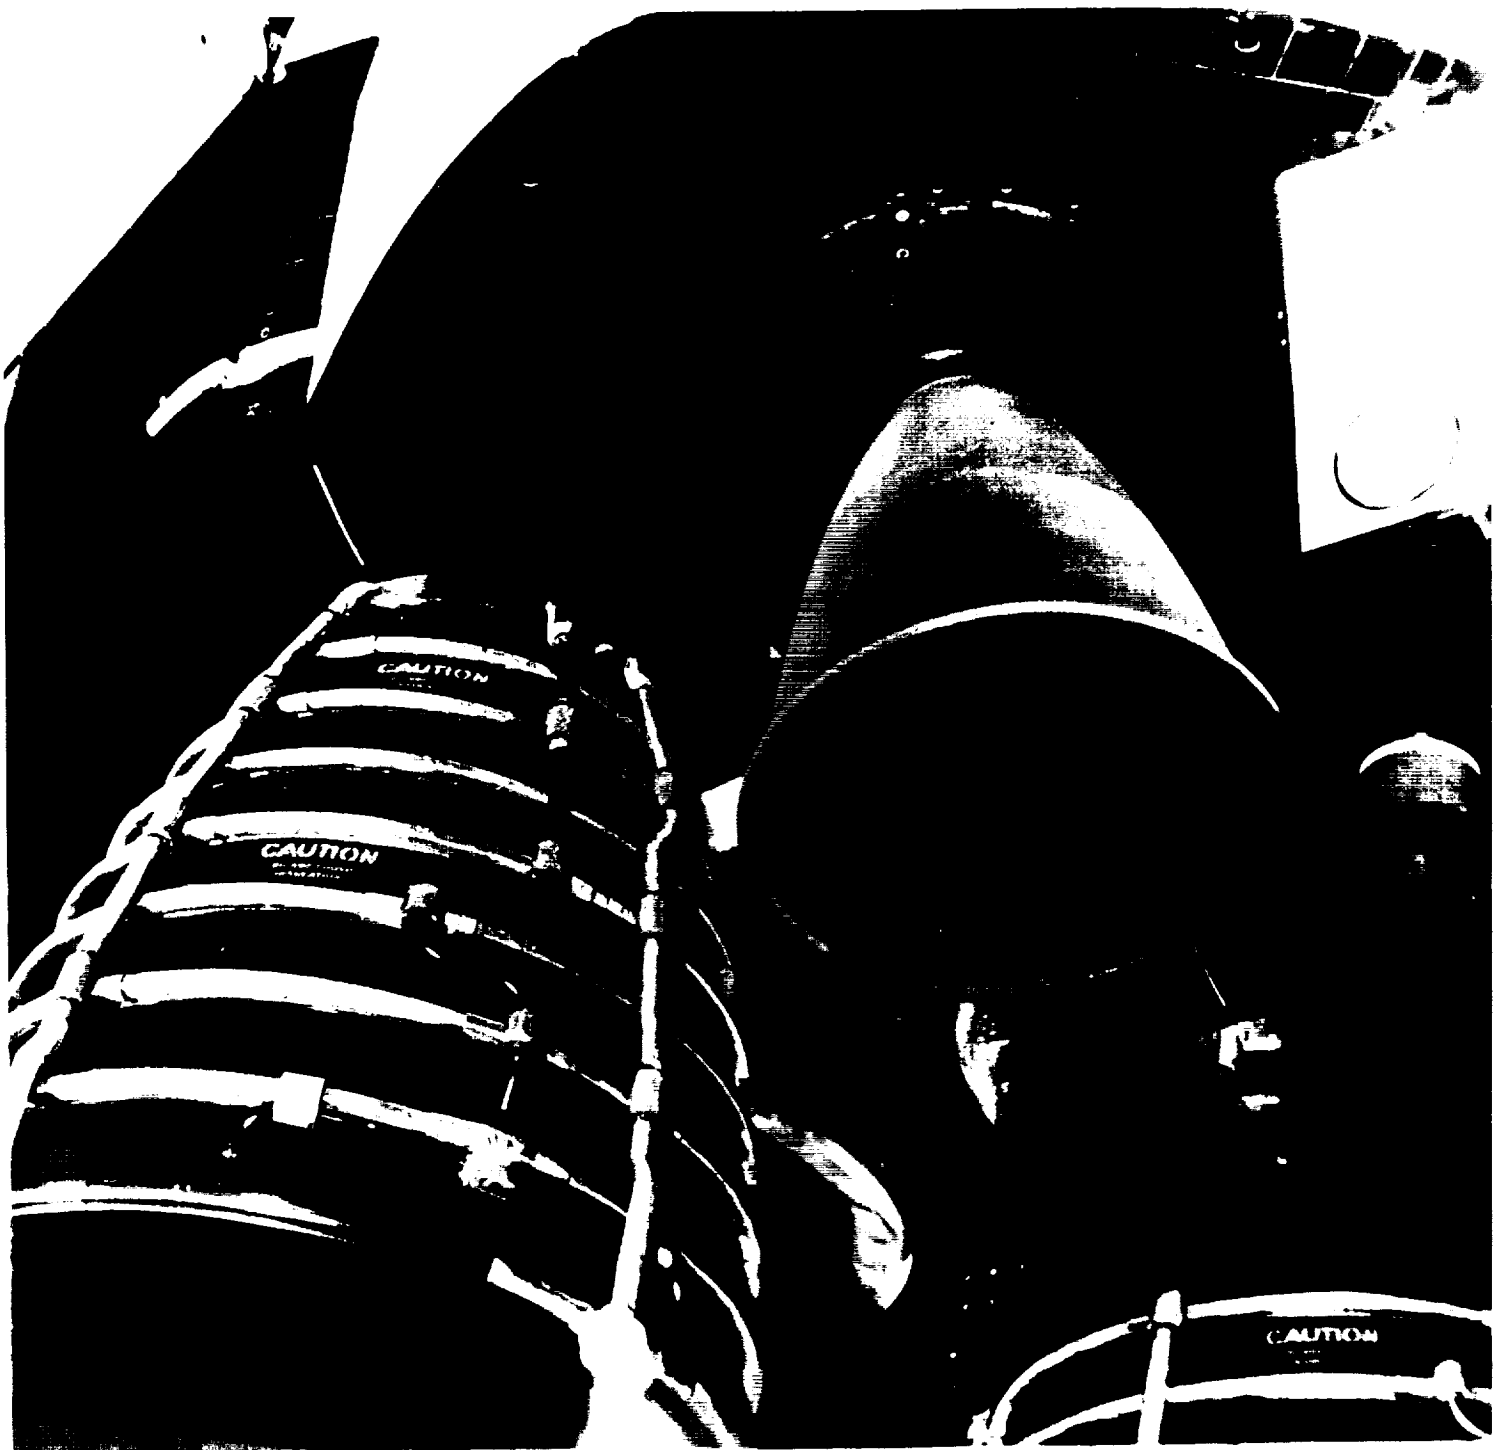
Overall view of OV-103 SSME's. Less than usual ice/frost had formed at the engine heat shield-to-nozzle interface. Some condensate was present on the SSME heatshields.

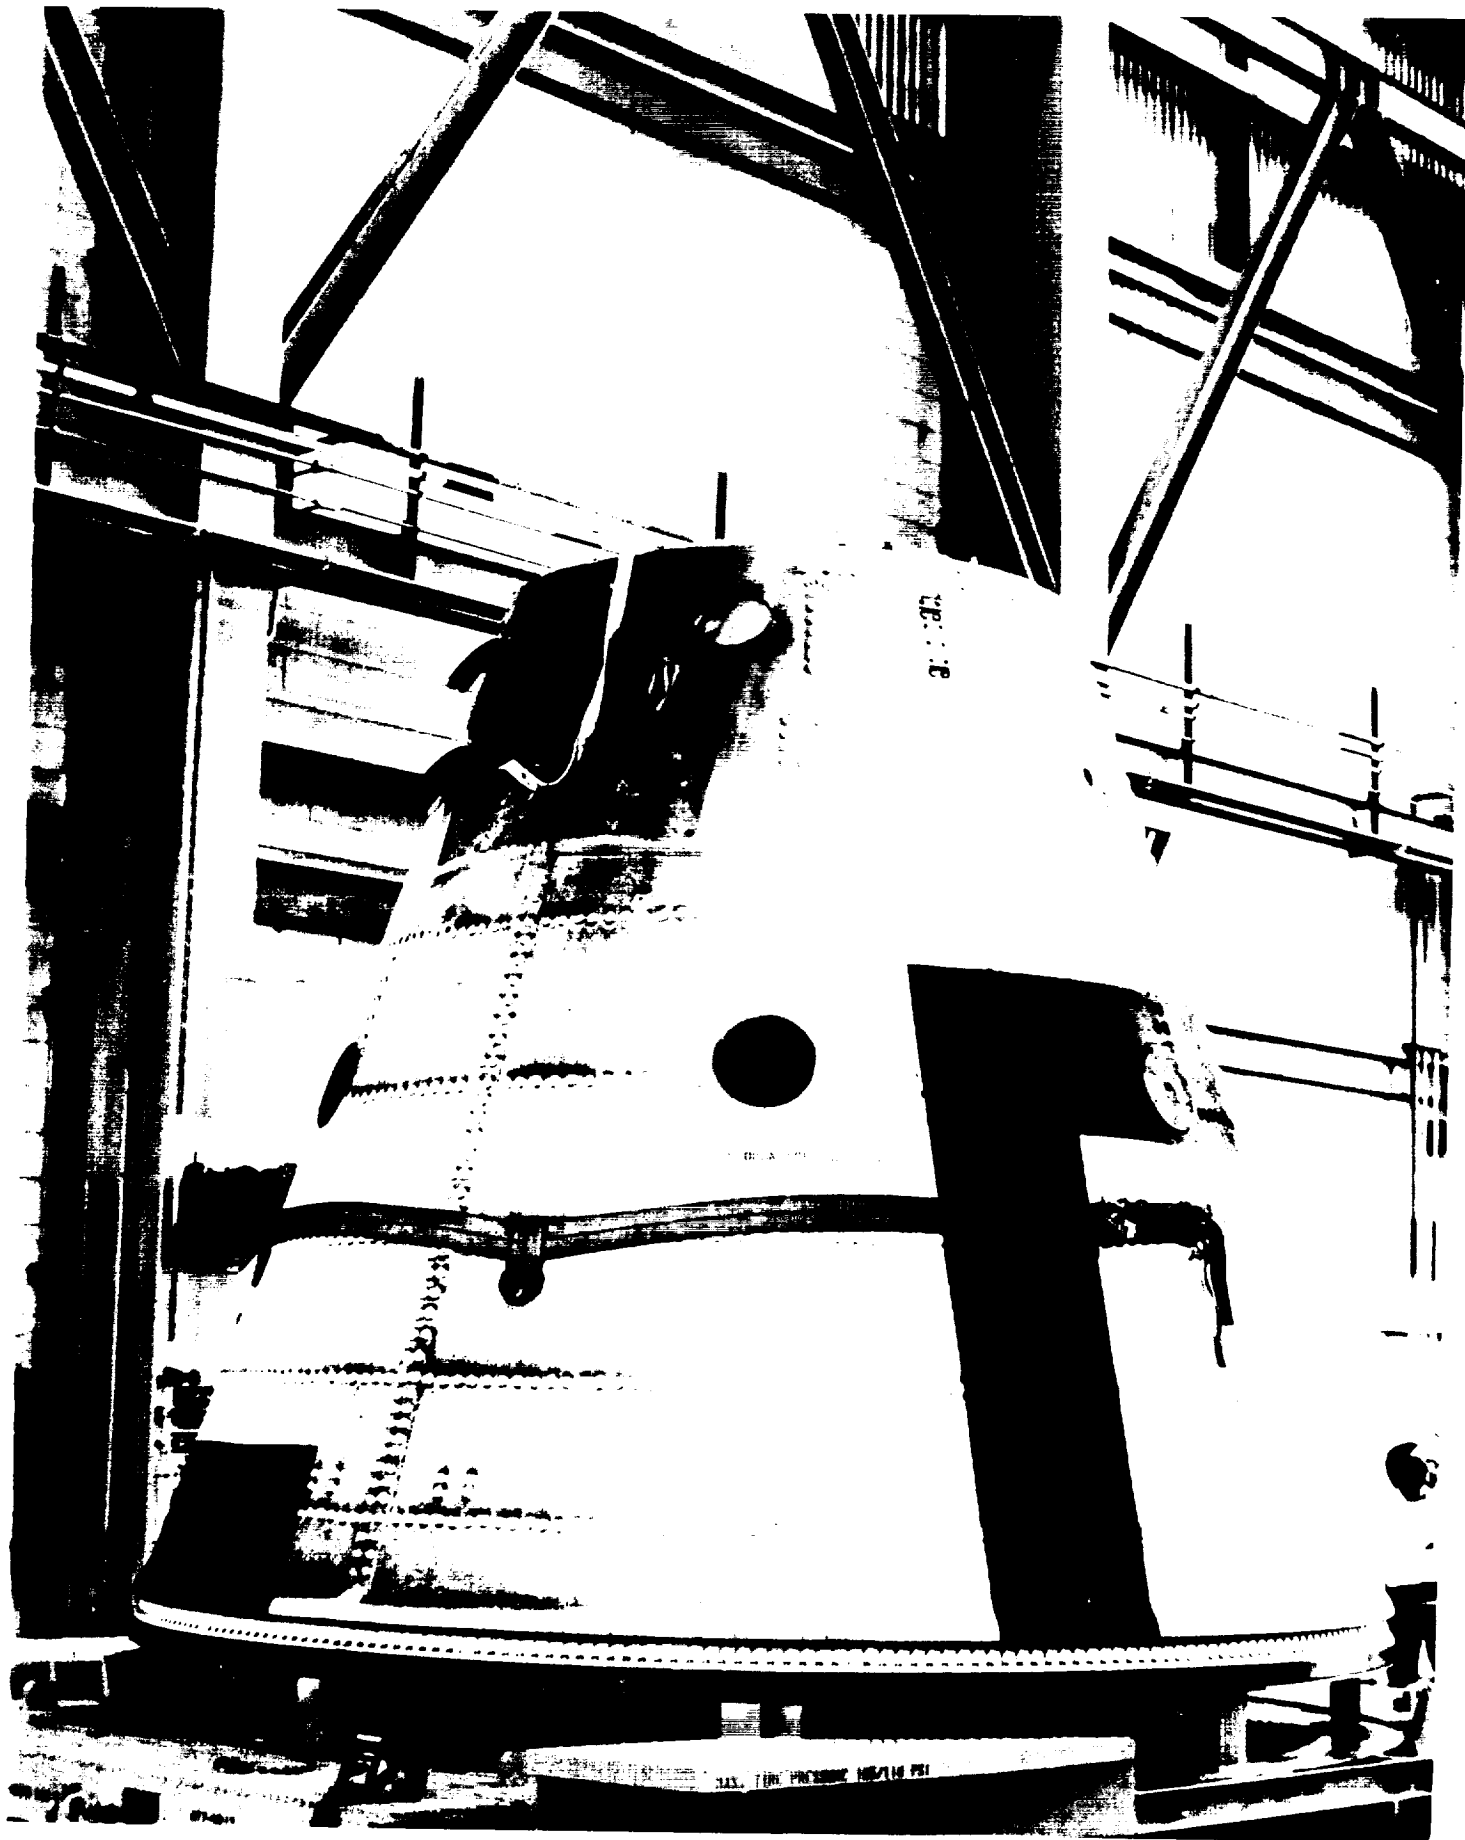
Post flight condition of the RH frustum. There were 52 MSA-2 debonds over fasteners, but no areas of missing TPS.

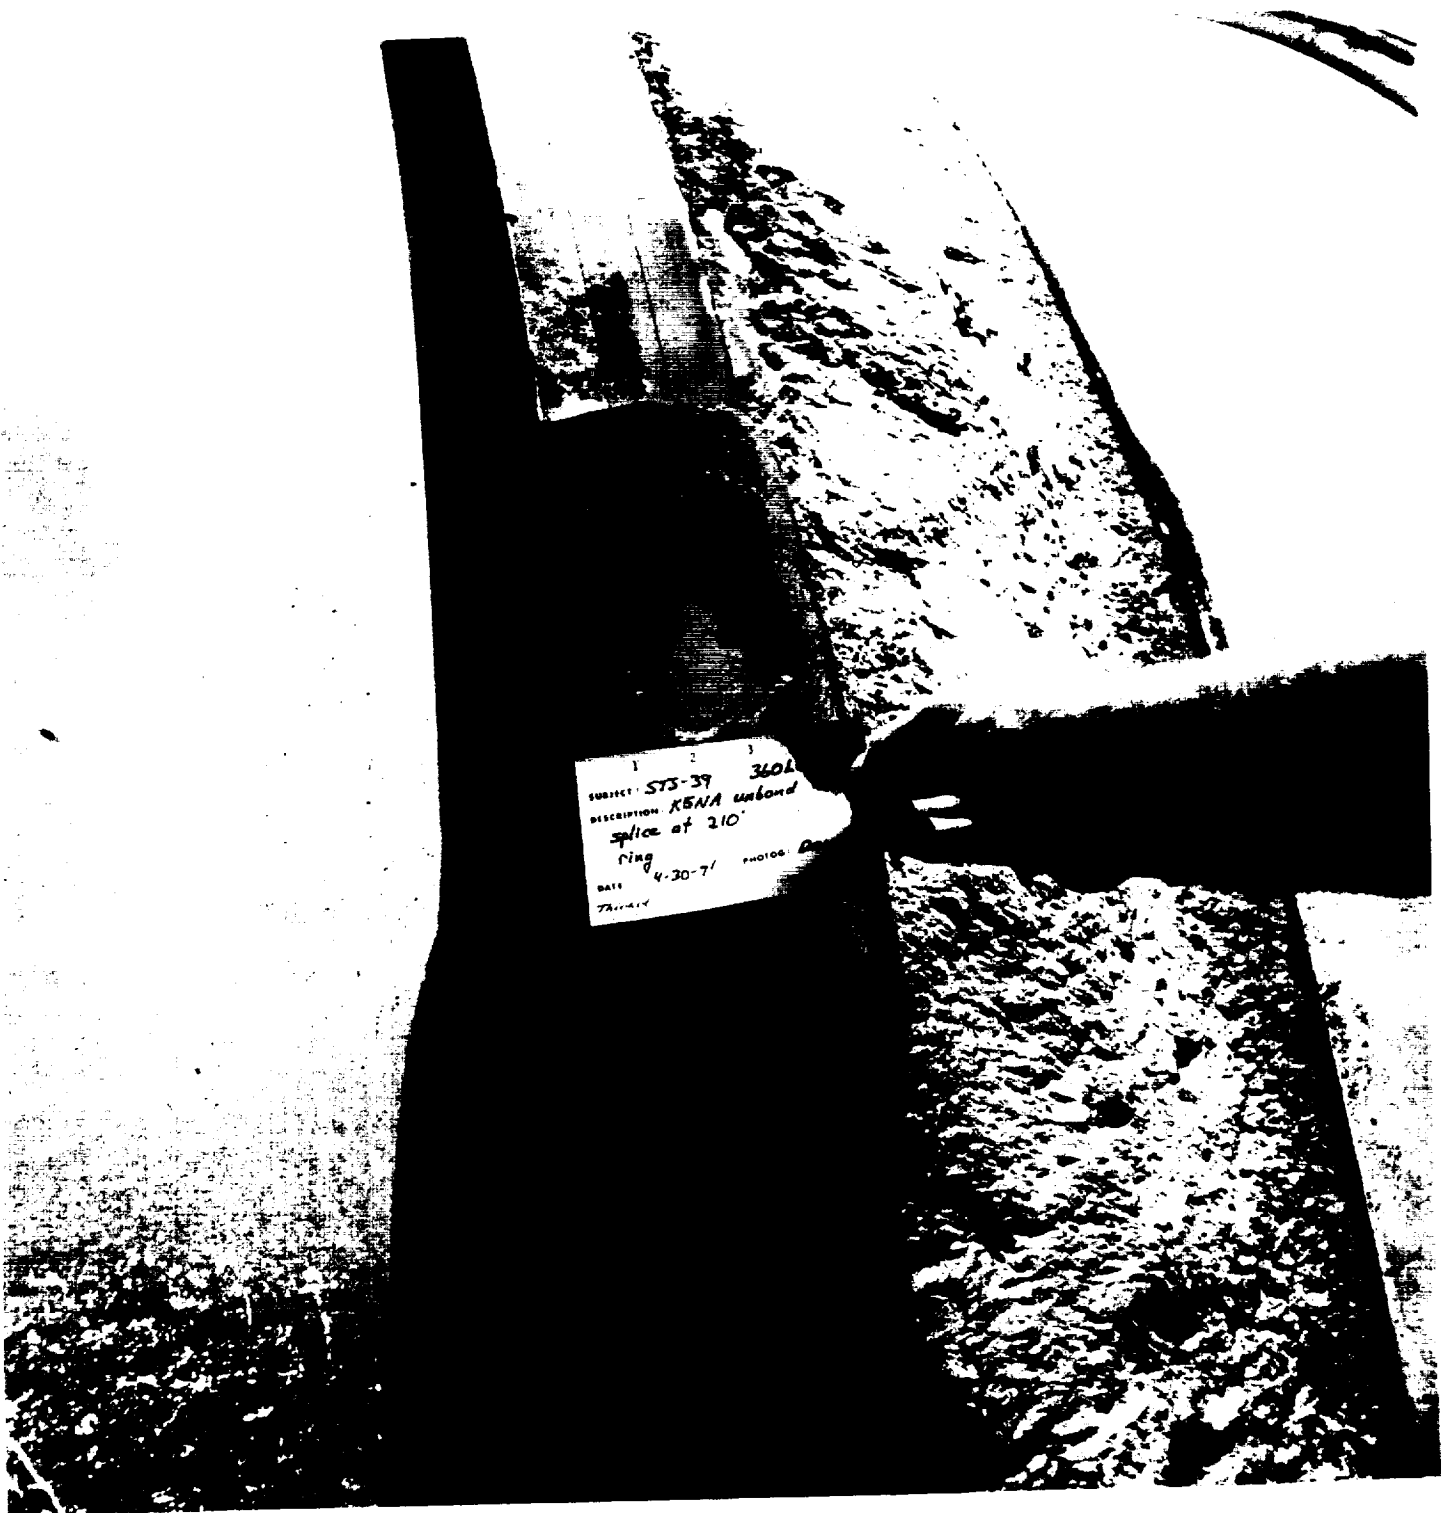
K5NA was missing from the RH aft booster stiffener ring splice plates (aft ring at 330 degrees, forward ring at 210 degrees). The substrate was not charred and loss of the material occurred at water impact.

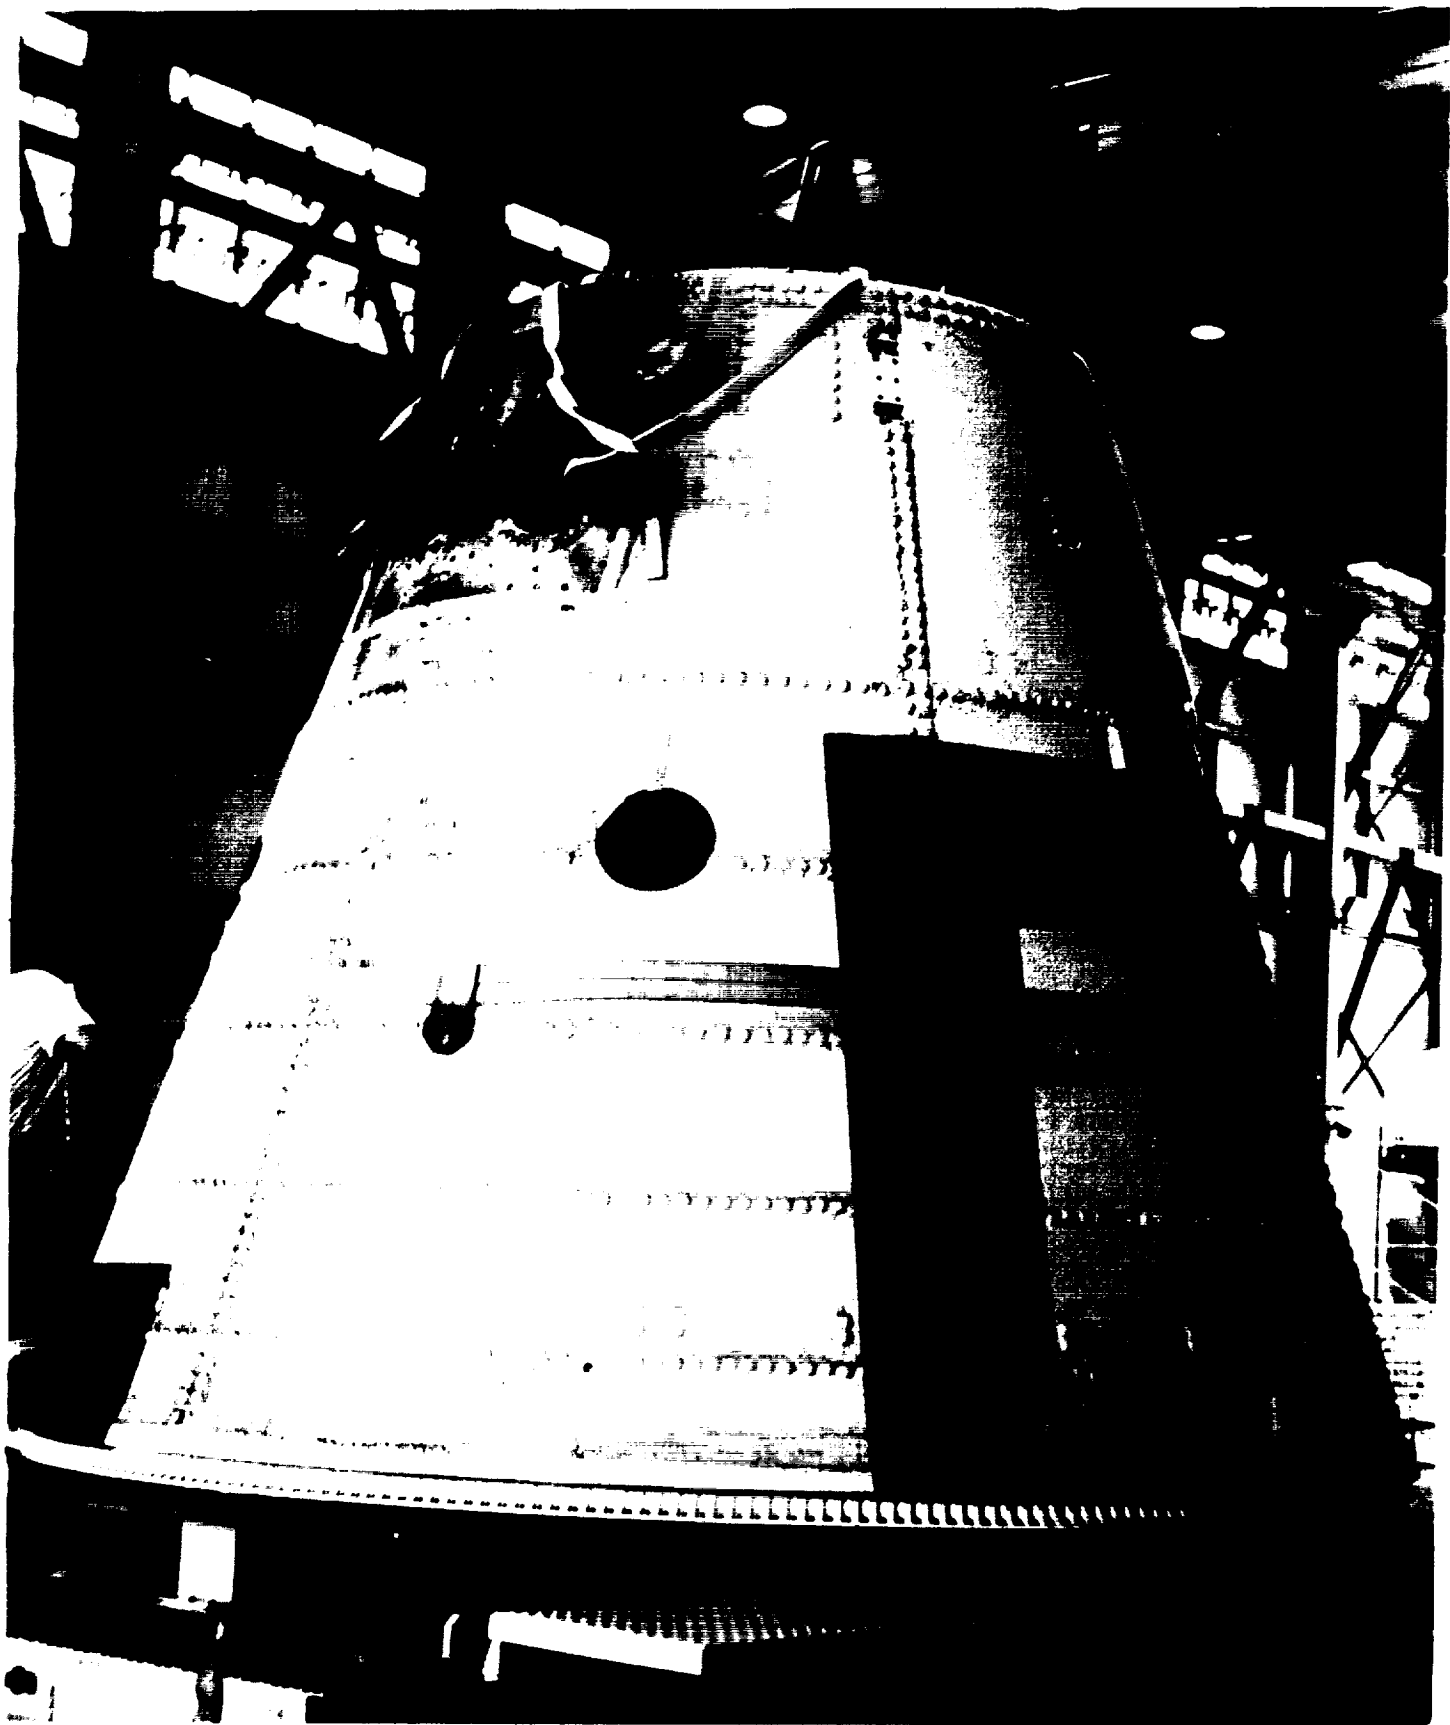
Post flight condition of the LH frustum. There were 22 MSA-2 debonds over fasteners, but no missing TPS.

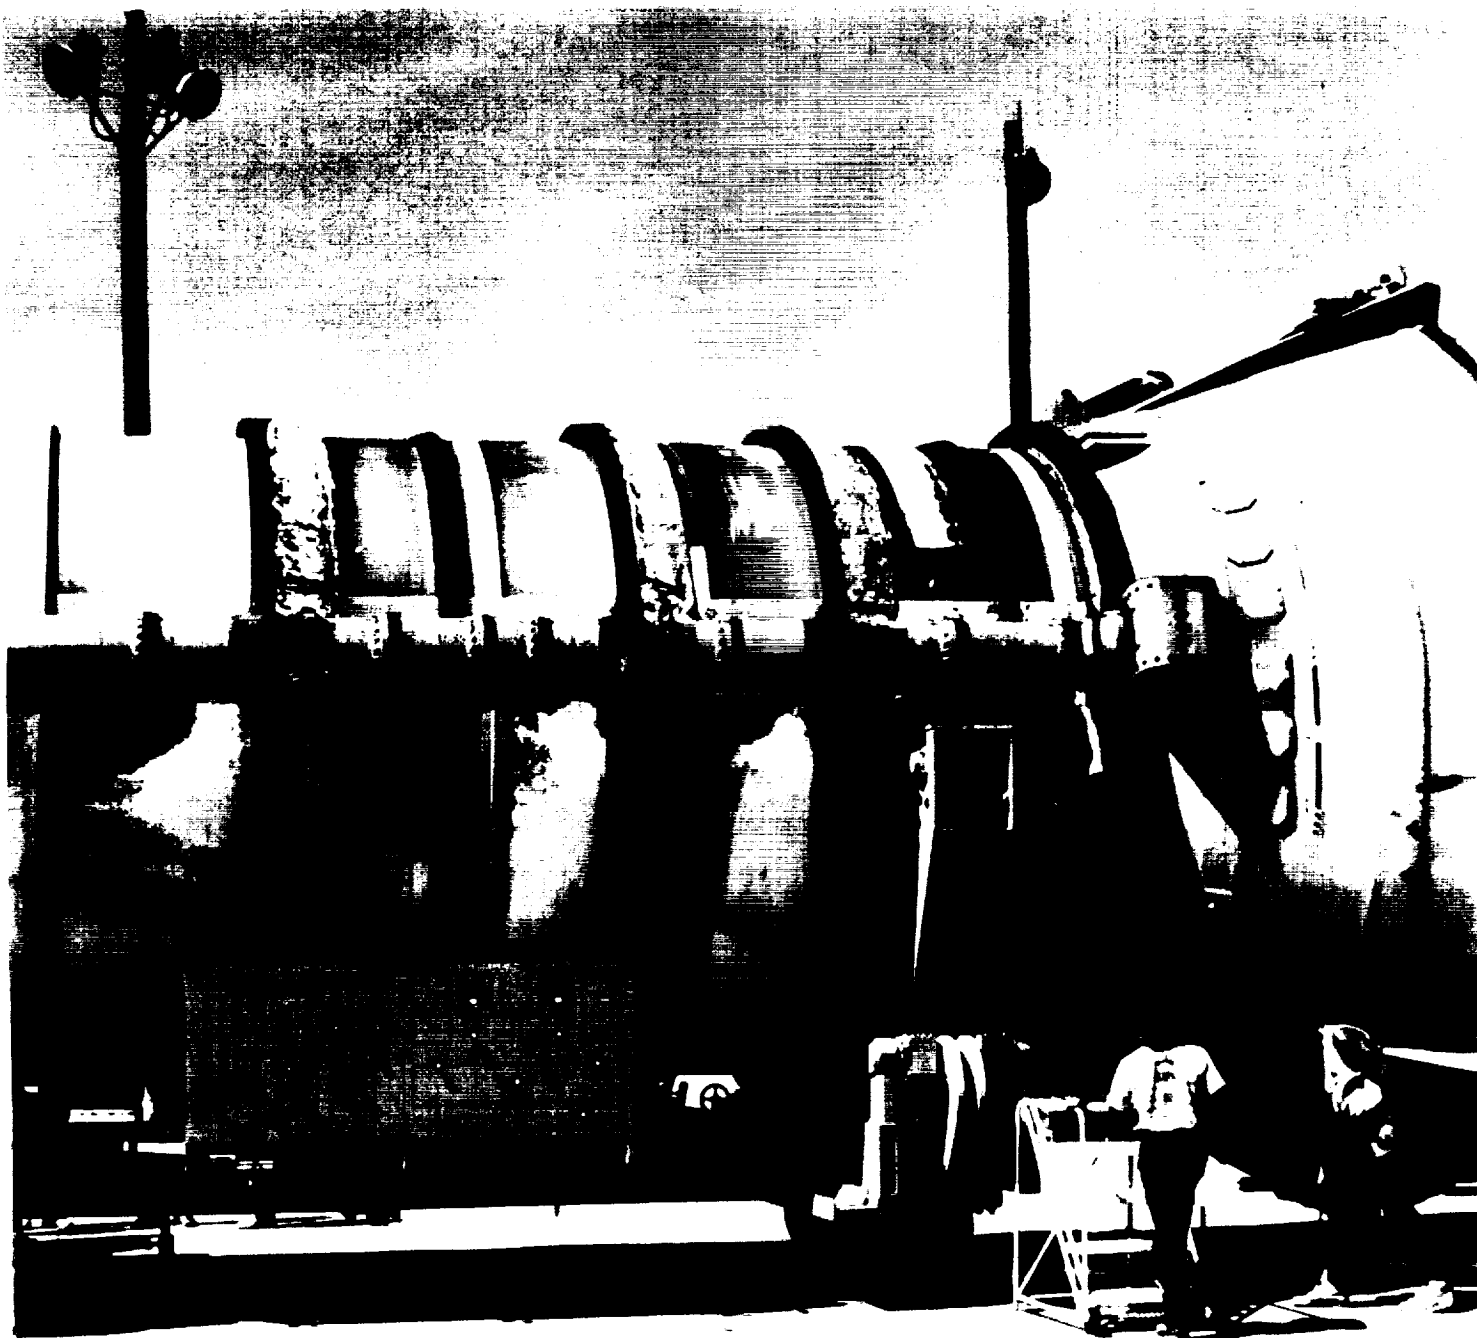
Post flight condition of the LH aft booster. All three stiffener rings were damaged by water impact.

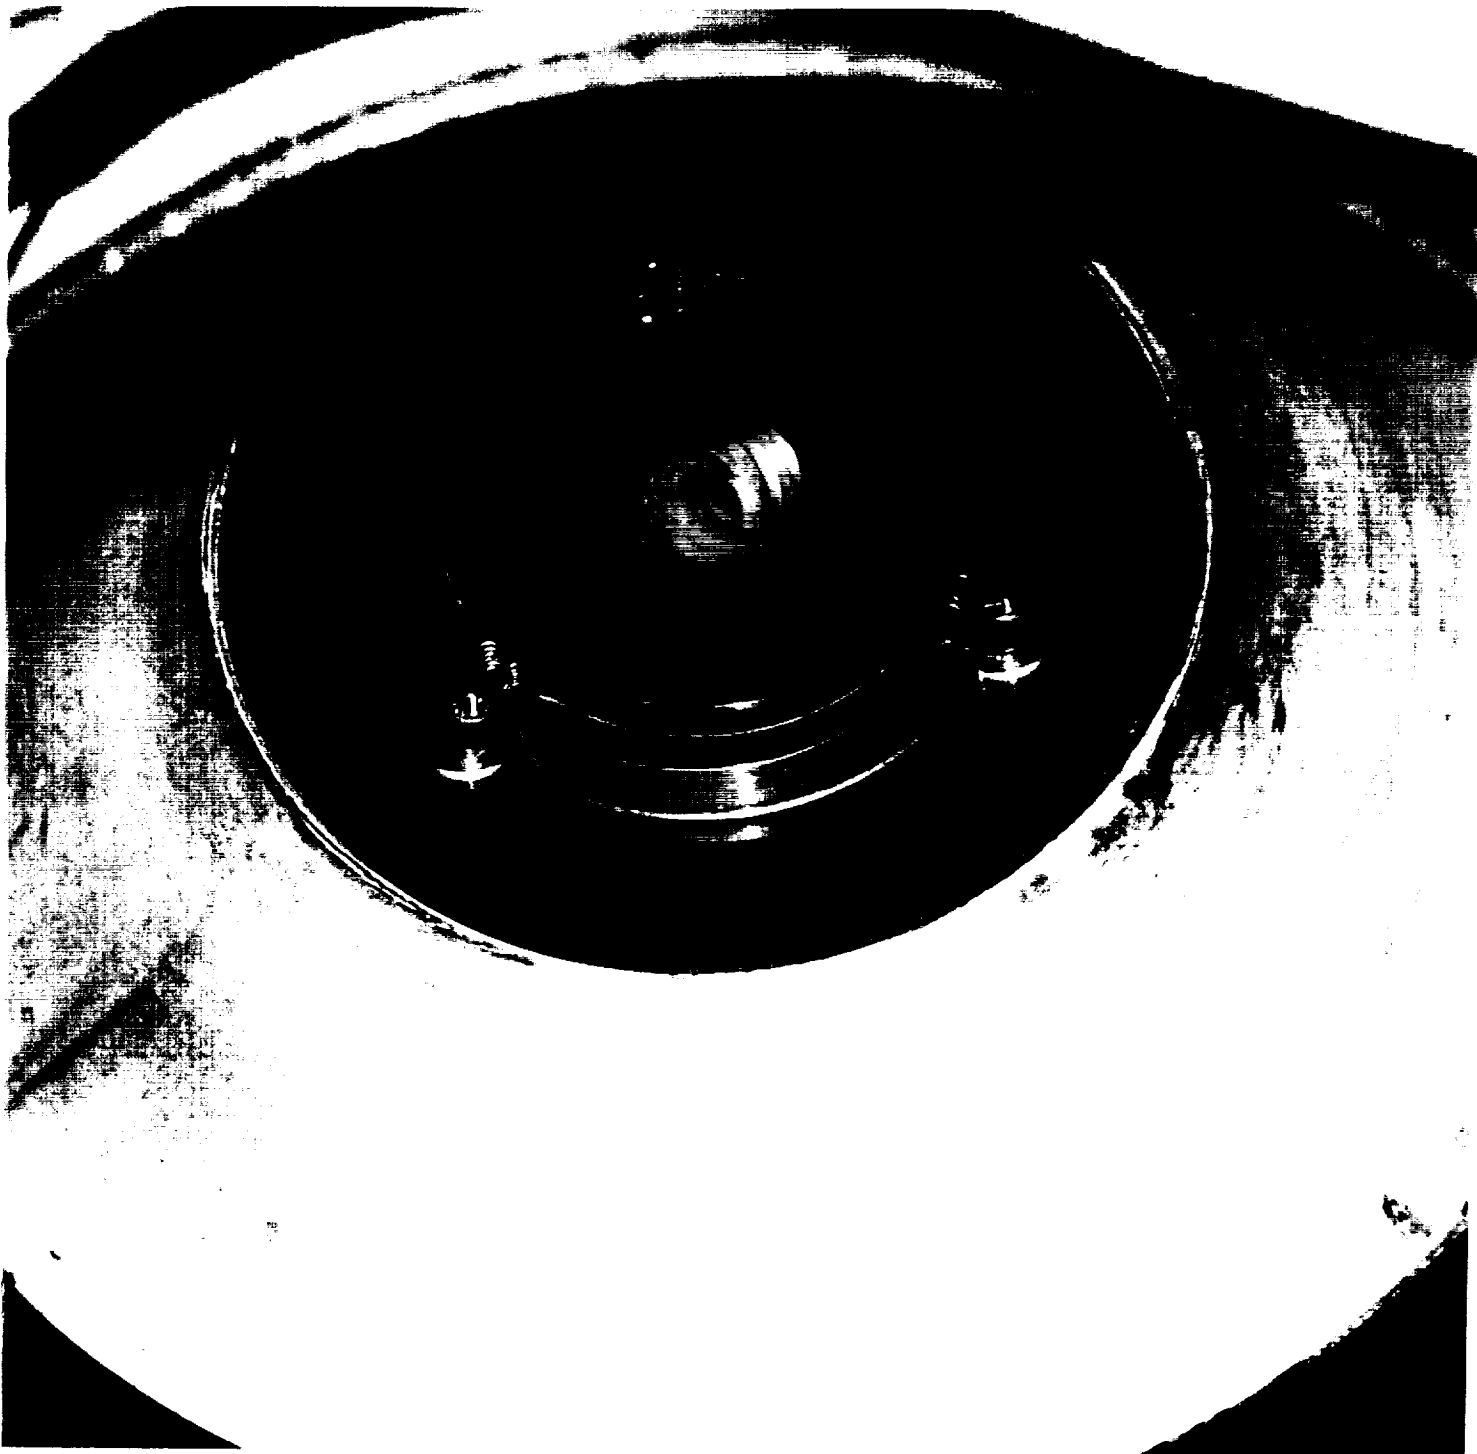
EO-3 debris plunger was obstructed by an NSI cartridge fragment

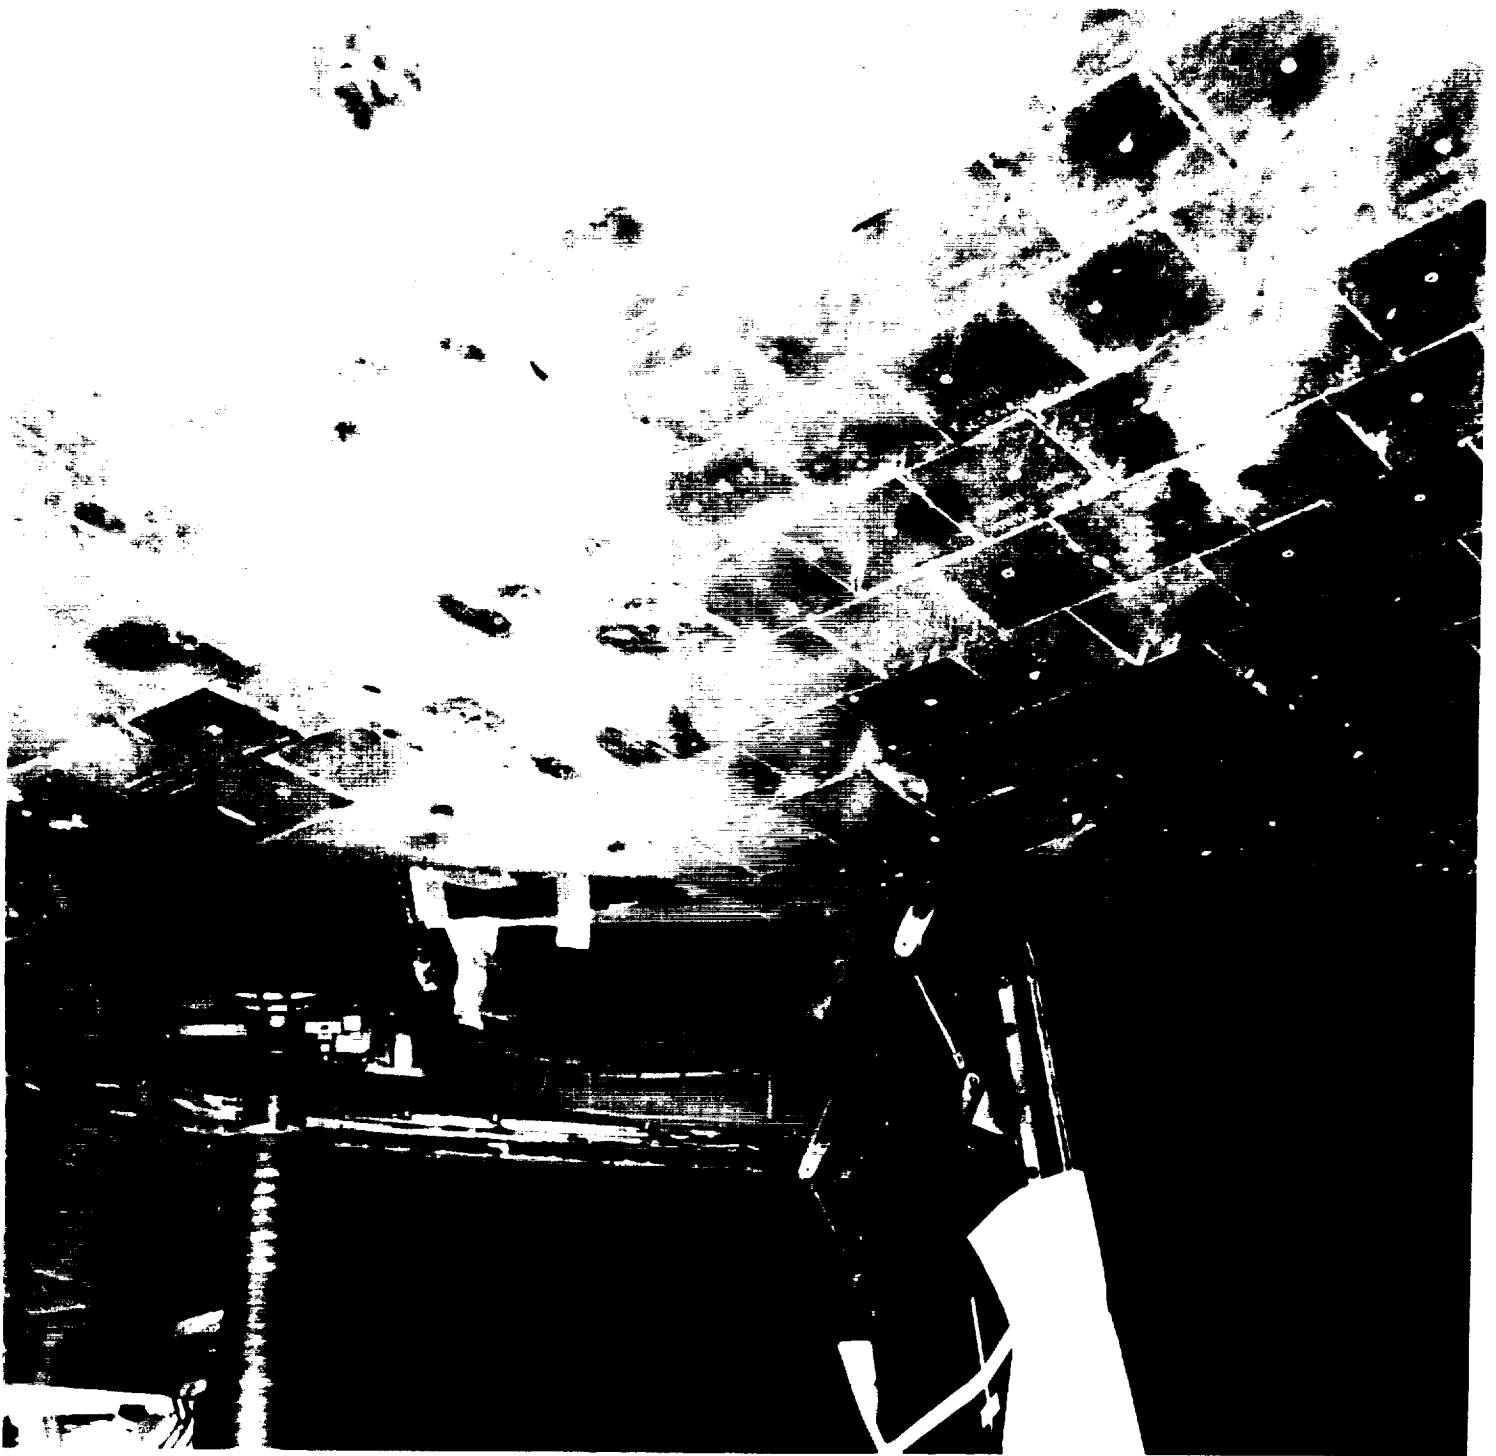
Cluster of hits on the tiles aft of the LH2 ET/ORB umbilical is typically caused by ice impacts during ascent and separation

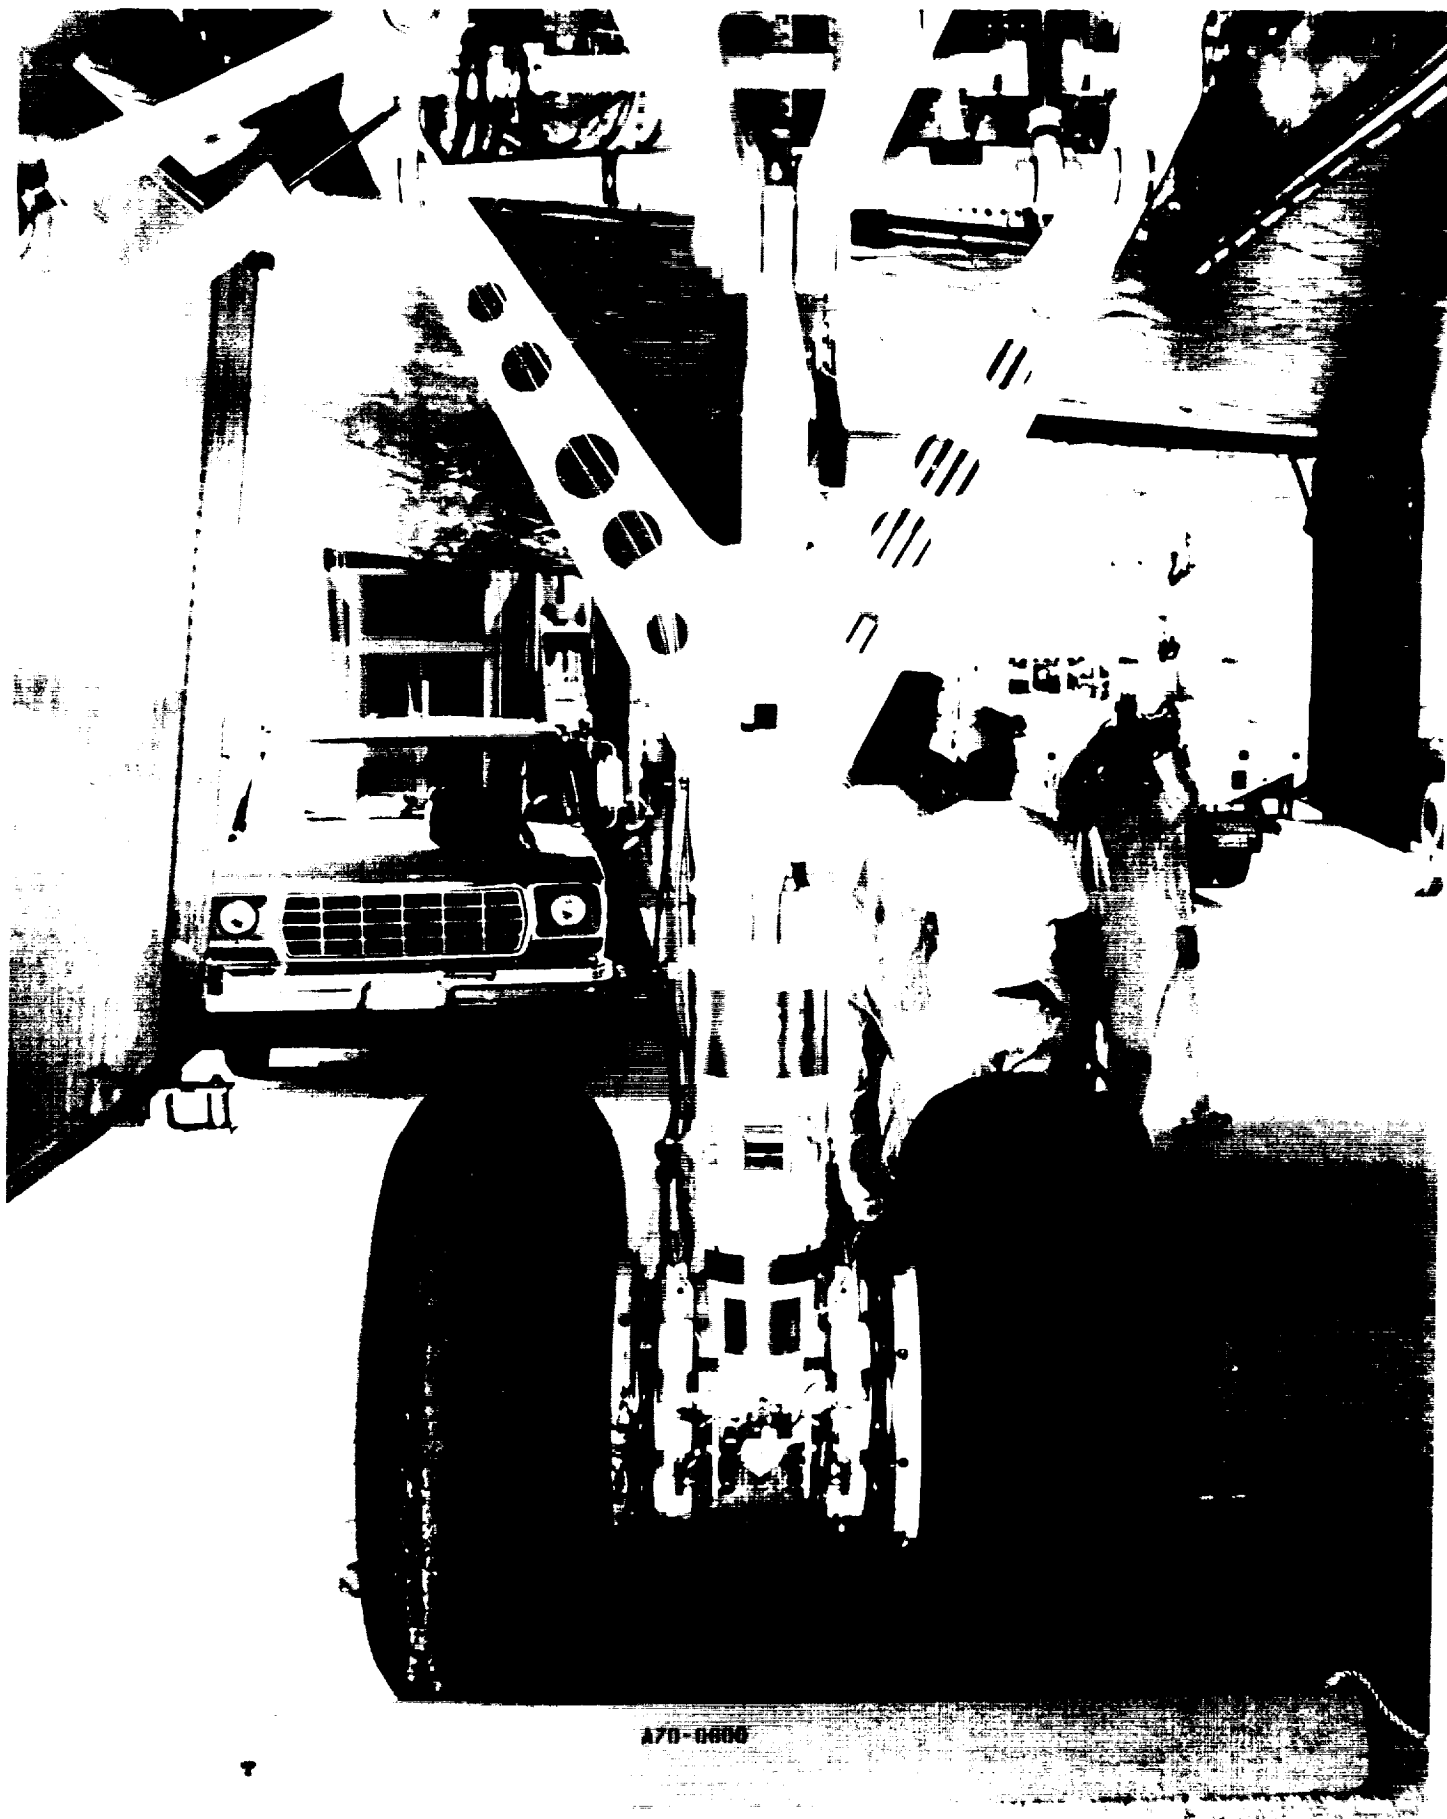
A70-0800

No tile damage was attributed to the loss of tire material from
the main landing gear wheels
